Aviation Safety Department
2701 Forum Drive, D10
Grand Prairie, Texas 75052

AIRCRAFT WRECKAGE EXAM NOTES
Era Helicopters, Eurocopter AS250B2, S/N 3158
Sheep Mountain, Alaska
15 April 2008, 0923 LDT

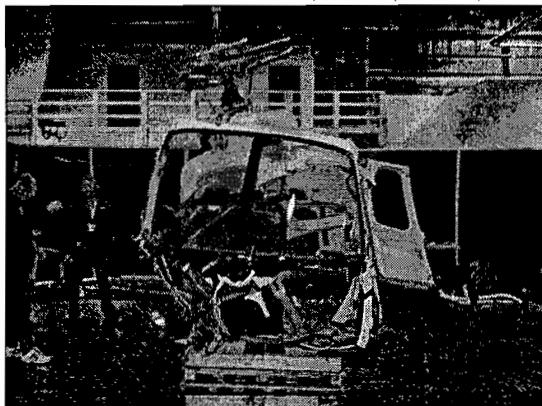
A. Main Fuselage

- The main fuselage sustained damage consistent with a low forward speed, vertical impact on the lower right side of the fuselage.
- Crushing was observed on right lower fuselage.
- Aft right cabin door was crushed.

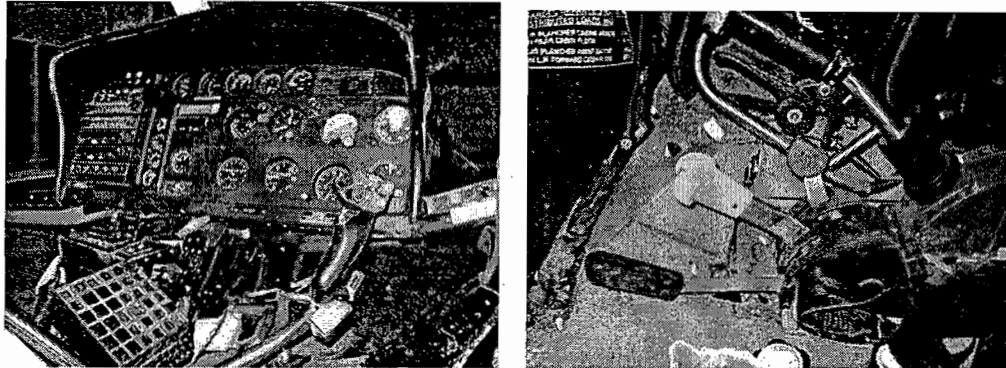
B. Cabin

- The antitorque pedals were jammed in a left pedal forward position.
- The fuel cutoff lever was found in the cutoff position with safety wire broken.
- The rotor brake was in the stowed position.
- The Fuel Flow Control Lever (FFCL) was found jammed just slightly forward of the flight detent.
- FFCL and collective control continuity was confirmed to engine controls.
- Directional gyro indicated a 250-degree heading.
- All gauges were at zero, except Delta NG at -11 and Torque at 8.
- Transponder was set to 0700-ALT.
- FUEL PUMP, GENE, A/COL, PULSE LIGHT, AVIONICS MASTER, BELLY STROBE, DG, and FLOAT ARM pushbuttons on the center console were depressed.
- Cabin headliner was partially detached and hanging in the cabin area.
- Both front bucket seats had torn from cabin floor mounts.

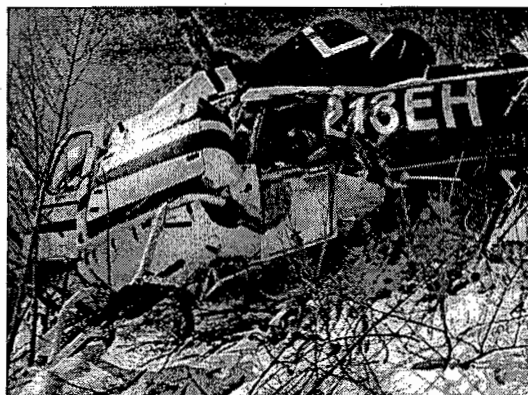
C. Landing Gear

- Cross tubes were still attached at site.
- Aircraft skids were equipped with "bear paws."
- Right skid was broken from cross tubes with "bear paw" attached at recovery site.

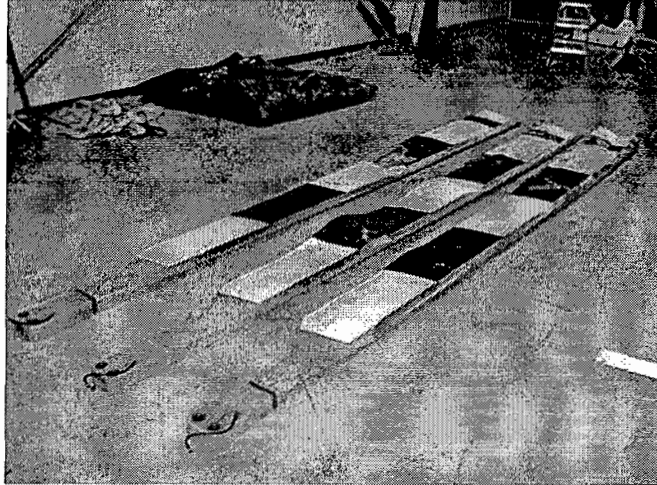
D. Main Rotor System

- Main rotor blades exhibited chord wise bending and trailing edge splitting.
- Evidence of impact with small trees and branches was observed on main rotor blade leading edges, particularly outboard half of red blade.
- Vertical puncturing of blade skin was observed on the outboard sections.
- Overall, blades exhibited signatures consistent with low rotor RPM at impact.

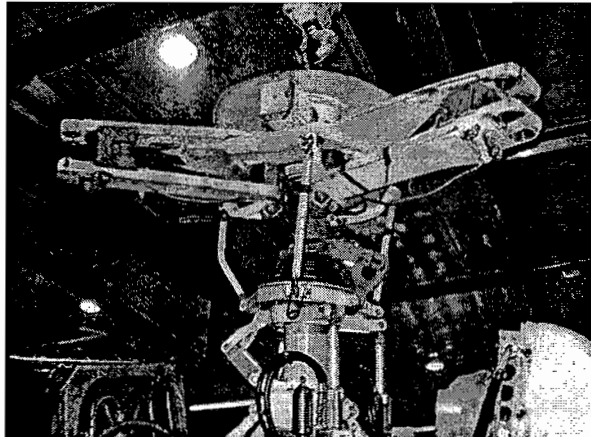
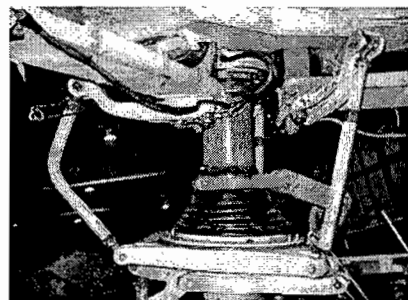
- The main rotor system could be rotated by hand in both directions with corresponding rotation of tail rotor output flange on aft end of engine.
- Both forward transmission support bars were broken and exhibited angular fracture surfaces.
- The yellow star arm fractured at an approximate 60-degree angle
- The blue star arm separated from its respective frequency adapter bushing.
- The red star arm remained intact

- All main rotor pitch links remained attached; the yellow pitch link exhibited a static bend (bowed outward).
- Control continuity was confirmed from the cyclic and collective controls to the left lateral servo.
- The fore/aft and right lateral servo input rods were broken at transmission deck and exhibited angular fracture surfaces.
- Control continuity was confirmed from the cyclic and collective controls to the break in the fore/aft control input rod.
- Another break in the right lateral control rod was observed at the mixing unit with angular fracture surfaces; control continuity from the cyclic and collective controls was confirmed to this point.
- Control tubes between mixing unit and transmission deck were warped due to impact.
- All control tube hardware was observed to be present and attached.

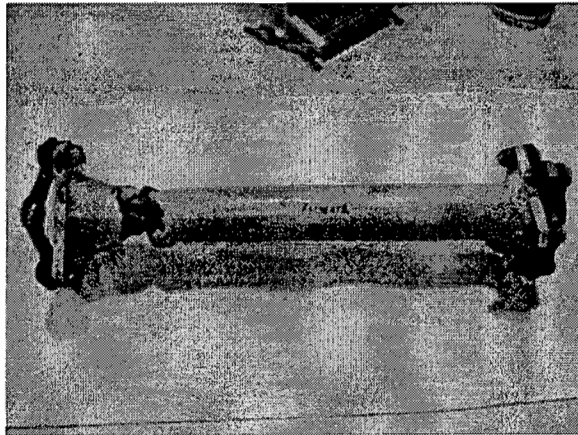
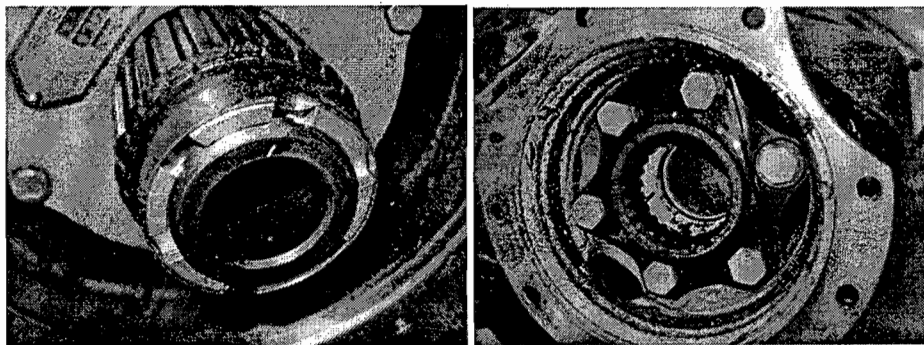
- The engine to main transmission drive shaft remained attached to the transmission input flange.
- The shaft was found twisted but not separated near the forward flange, reducing the length of the shaft, which had resulted in partial spline disengagement (backing-off)
- The engine output spline (left) and aft shaft spline input (right) exhibited rotational damage and polishing; metal debris was observed in the area.

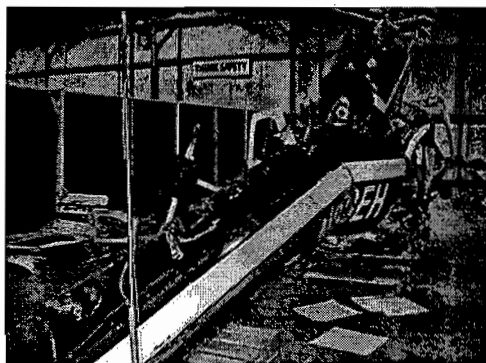
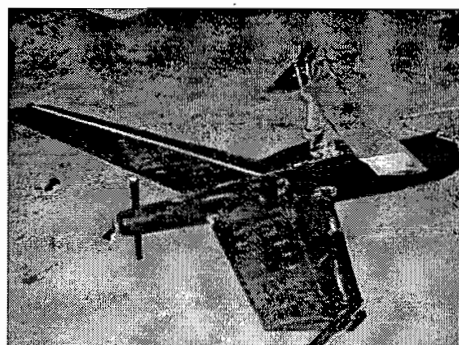
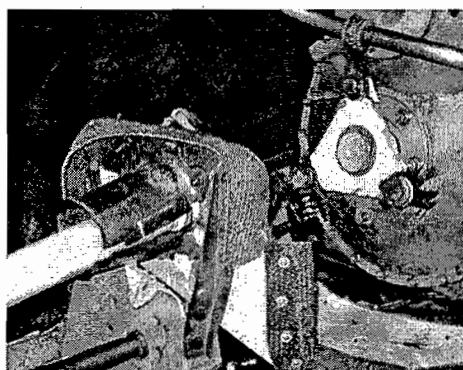
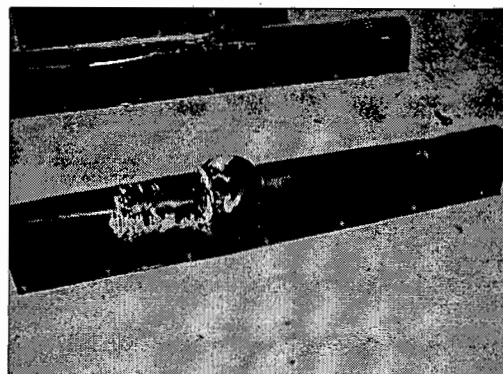
E. Tailboom and Tail Rotor Drive System

- The tailboom was crushed downward near the fuselage attach area.
- The right horizontal stabilizer was crushed upward and aft.
- The tail rotor assembly separated from the tailboom just aft of the horizontal stabilizer.

- The forward tail rotor drive shaft flex coupling was found splayed and torsionally separated from the engine output flange.
- The short and long tail rotor drive shafts had decoupled at the spline connection.

- Corresponding rotational scoring from flailing was observed on the interior surface of the tail rotor drive shaft cowling.
- Tail rotor drive shaft and tail rotor pitch change rod were separated just aft of the horizontal stabilizer and exhibited angular fracture surfaces.

- Both paddles of the tail rotor assembly were cracked near the cuff and exhibited trailing edge splitting (low rpm signatures).
- Both tail rotor strike tabs were bent.

- Both boss weights had contacted the shaft with corresponding blue witness marks.
- The lower vertical fin was crushed slightly upward and left.
- The tail rotor gearbox rotated freely by hand.

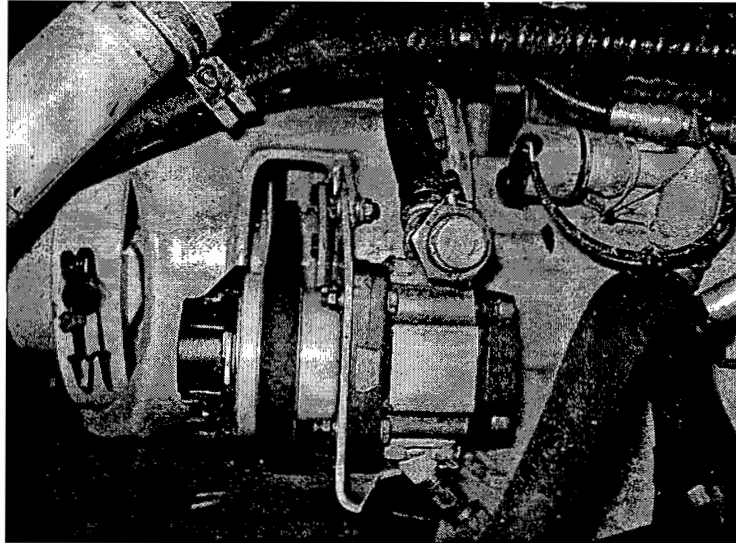
F. Hydraulic System

- All hydraulic system and servo hardware was observed to be present and connected.
- The hydraulic clogging indicator was not extended.
- The black hydraulic "poly-V" belt was found in place.
- The hydraulic pump was disassembled to check for spline coupling wear; spline coupling was properly lubricated and appeared normal.
- The HYD TEST pushbutton on the center console was not depressed.
- The hydraulic cutoff switch guard on the collective was broken/smashed, and the switch was in the down/hydraulics off position
- The HYD caution warning light bulb filaments appeared normal, not stretched.

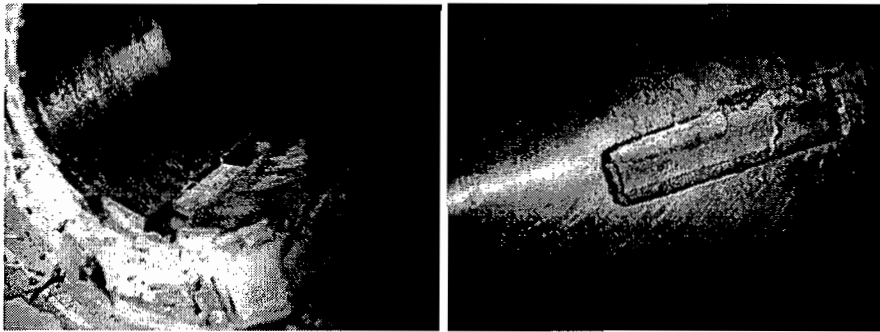
- Aircraft was equipped with snow/sand filter STC # SR00811SE
- Doors were designed to be opened via right pedestal switch when specified pressure differential was exceeded to ensure airflow; doors were found closed, switch was armed, but not activated.
- Aircraft was equipped with side baggage compartment "space pod" STC.
- 2 aircraft batteries were located in right baggage compartment.
- Tail rotor shaft key was examined following initial recovery examination and exhibited signatures consistent with an over torque event (see below)

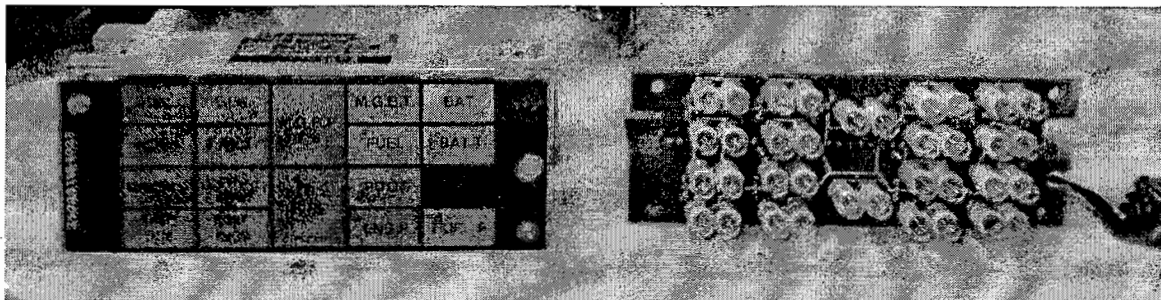
VI. CAUTION WARNING PANEL EXAM

- A light bulb filament analysis of the light bulbs contained within the caution warning panel was conducted (stretch indicates illumination at impact).
- Each of the cautions (seen on panel above) is designed to be illuminated by two light bulbs behind it.
- No filament stretch was observed on any of the light bulbs.
- Several light bulb filaments were broken with no apparent stretch; these were:
 - Both GEN
 - Left GEN
 - Right ENG.P
 - Left FUEL.P

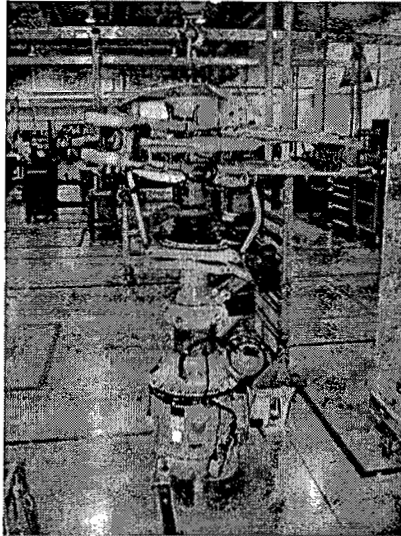
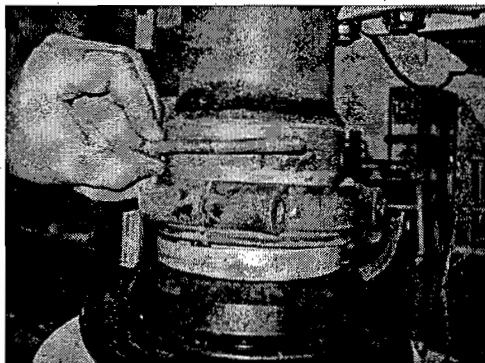
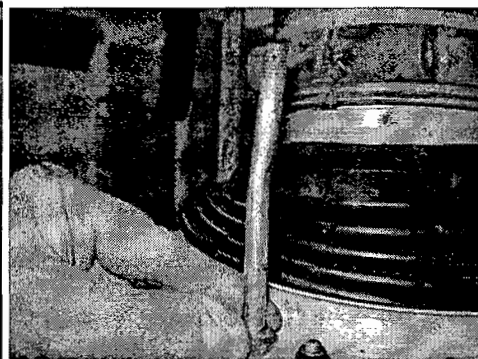
VII. MAIN TRANSMISSION EXAM

- The main transmission and rotor head assembly was examined on 21 May 2008 at American Eurocopter's Grand Prairie, Texas facility.
- The transmission was crated at Era, shipped, and secured until investigators arrived for examination.
- The main rotor head rotated freely with corresponding rotation of the transmission input flange.
- The magnetic chip detector was jammed, so the housing was removed; no metallic particles other than a very small piece were observed on the yellow magnetic surface.
- The rotor brake was disassembled and exhibited normal wear.
- The transmission was disassembled by module; no anomalies noted.
- A sufficient amount of oil was drained from the system.
- Epicyclic module magnetic plug was clean.
- The scissors drive bolt above the epicyclic was bent and exhibited contact damage with corresponding contact damage in its respective groove (see photos below).

- No anomalies were noted during the examination, which could have led to loss of rotation or sudden torque spike.
